**Failure Analysis, Cadmium Brush Plate Qualification and
Salt Fog Testing of the AH-64 Shock Strut Mount,
P/N 7-311113409**

ARL-TR-2870

November 2002

A failure analysis was performed on a shock strut mount from an AH-64 Apache attack helicopter. It was concluded that the failure was attributed to stress corrosion cracking and/or corrosion fatigue and had initiated at a region where the protective cadmium plating was worn away in service. Based upon this conclusion, it was necessary to qualify two facilities (Hunter Army Air Field, Savannah, GA and Ft. Lewis, Dupont, WA) for the cadmium brush plating rework of these components found to have worn coatings during routine inspections. The U.S. Army Research Laboratory was involved in the qualification process for both facilities, and the results of each quality audit are included. Finally, the results of salt fog testing of cadmium brush plated specimens, plated at the respective facilities, are also included, as well as a comparison of the grain size of the material in the failed component vs. the material from the struts plated at each facility.

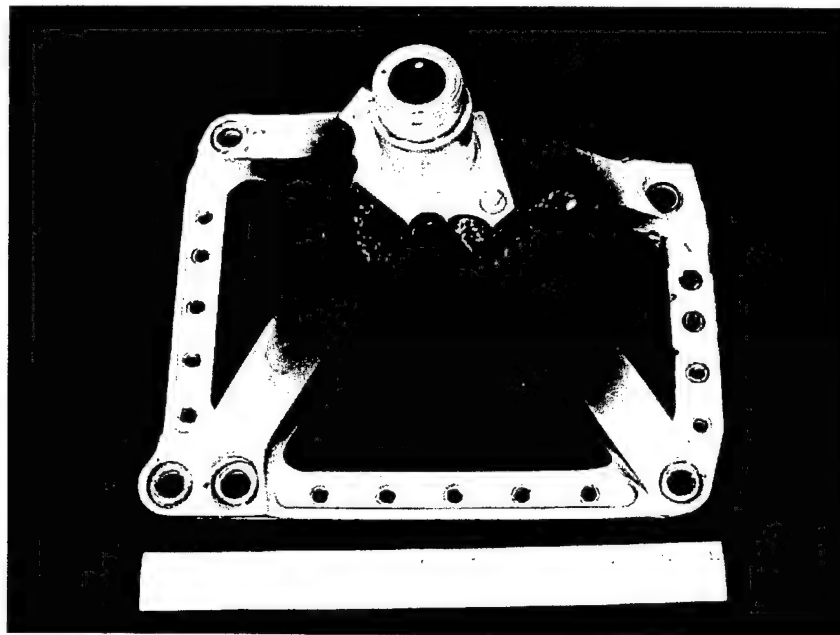
The U.S. Army Aviation and Missile Command (AMCOM) requested the qualification of two facilities for the cadmium brush plating of AH-64 landing support struts (shown in Figure C-1). The facilities would perform rework in the spindle to webbing radius that has been the origin of many failures over the past decade. As part of the qualification process, the U.S. Army Research Laboratory (ARL) performed hydrogen embrittlement testing on specimens that were cadmium brush plated by the Hunter Army Air Field (HAAF), Savannah, GA, and Ft. Lewis, WA. Each facility used a "no-bake," non-embrittling solution for plating. The specimens were produced in accordance with American Society for Testing and Materials (ASTM) G39¹ from two separate AH-64 Landing Support Struts comprised of Maraging 300 Grade steel. Each specimen withstood 8 weeks of ambient exposure (75 °F and 50% relative humidity) at 80% and 92% ultimate tensile strength (UTS) loading without failure. Based upon the results of ambient loading, the two facilities were qualified to perform cadmium brush plating operations.

Figure C-1. Intact shock strut mount shown in the as-received condition (reduced 75%).

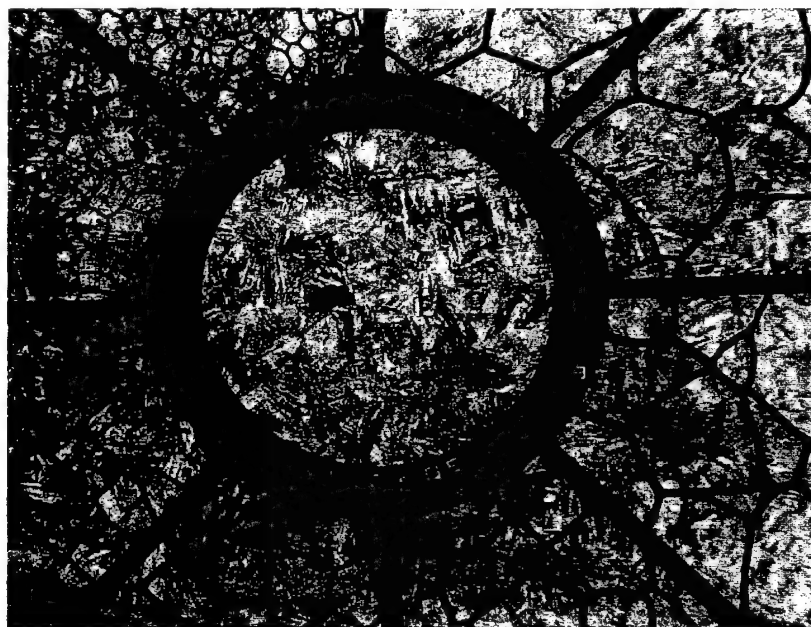
Representative SCC specimens coated by HAAF and Ft. Lewis were sectioned in order that a metallographic examination could be performed. Transverse and longitudinal samples were polished then etched with Marble's Reagent (4-g CuSO₄, 20-mL HCl, and 20-mL deionized water). The structure was similar in both orientations, consisting of an aged, low-carbon martensite. In addition, the material was fairly clean, exhibiting no gross defects or inclusions. Paragraph 3.4.1.3 of specification HMS 6-1081 requires a grain size of no. 7 or finer with an occasional no. 5 unless otherwise specified for material up to 3-inches in diameter or square. The grain size was determined using a metallograph with grain size reticle conforming to ASTM E112.³ It was determined that the grain size was between ASTM nos. 6 and 7 at 100× magnification for both the HAAF and the Ft. Lewis specimens (Figures C-3 and C-4), and no appreciable difference existed between the two.

Figure C-3. Grain size of a representative HAAF specimen (mag. 100×).

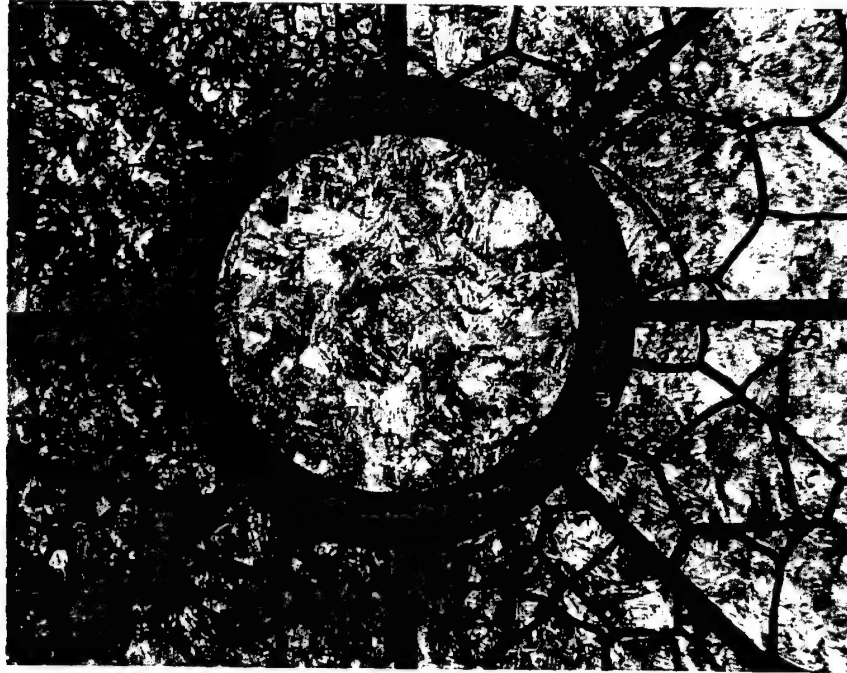
Figure C-4. Grain size of a representative Ft. Lewis specimen (mag. 100 \times).

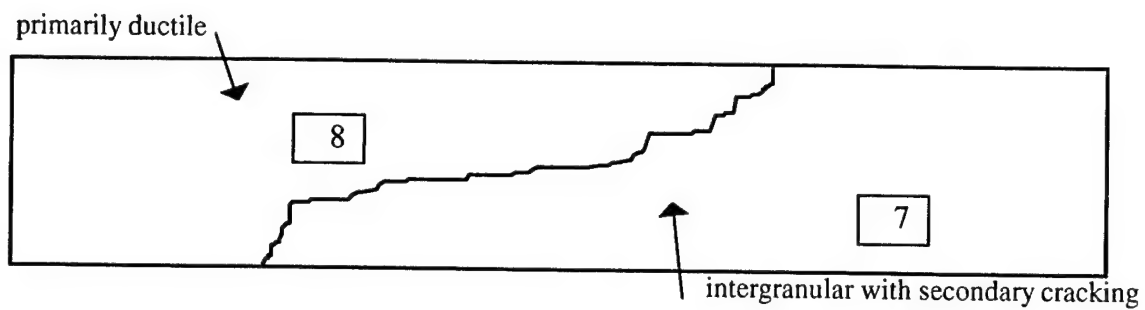
Figure C-6. Schematic illustrating a mapping of the fractographic features of the surface shown in Figure C-5. Boxes show locations of Figures C-7 and C-8.

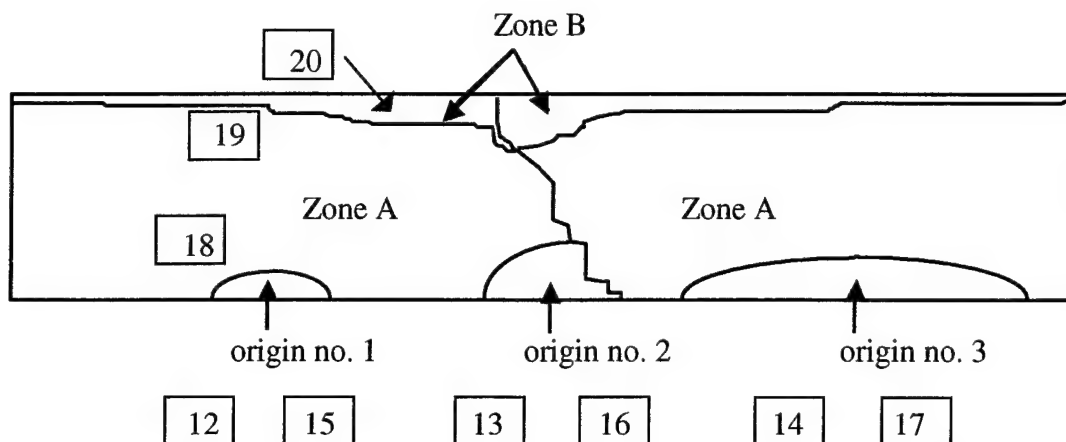
Figure C-9 contains a montage of a typical Ft. Lewis failure, while Figure C-10 contains the accompanying schematic map. The fracture surfaces of the broken Ft. Lewis specimens consisted primarily of a transgranular, quasi-cleavage morphology (Figure C-11). The fracture of one of the specimens consisted of two planes with three distinct origins on the tensile side of the specimen and had the appearance of a ductile fracture. The surface was predominantly transgranular with evidence of intergranular attack and secondary cracking only at each of the three origins. Ductile dimples were noted on the compressive side of the specimen, which was the last to fail. Figures C-12 through C-14 represent the three origins at 100 \times magnification, while Figures C-15 through C-17 show the origins at higher magnification (200 \times). Figure C-18 represents the morphology noted within the center of the specimen (mixed mode; ductile and transgranular) as illustrated in Figure C-10, while Figure C-19 represents the morphology of near the compressive side of the specimen. Figure C-20 is a high-magnification scanning electron micrograph representing the ductile region (final fast fracture) on the fracture surface.

Figure C-10. Schematic illustrating a mapping of the fractographic features of the surface shown in Figure C-9. Boxes represent location of figures.

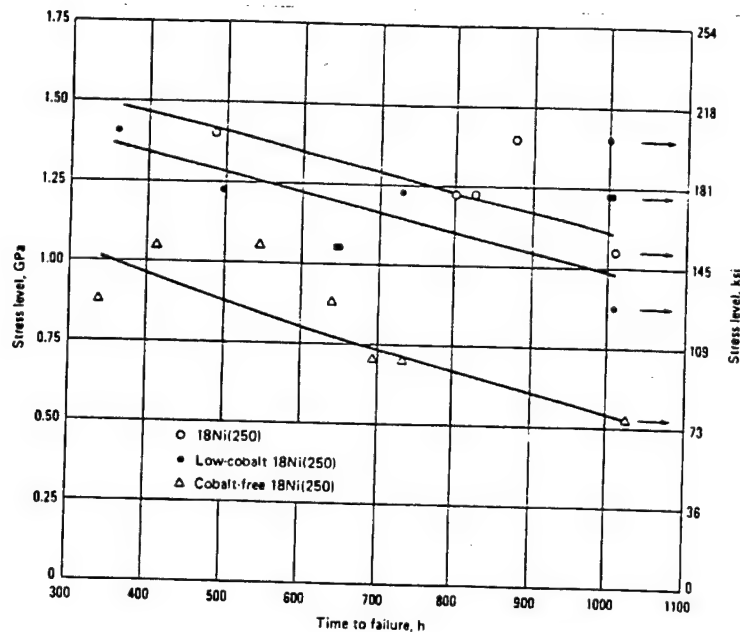
Figure C-21. Chart showing the effect of increased cobalt composition on the time-to-failure of maraging 250 steel. Plot compares 8% cobalt, 2% cobalt, and cobalt-free maraging 250 steel. Tests were conducted in stagnant 3.5% NaCl solution for 1000 hr using proof-ring specimens.

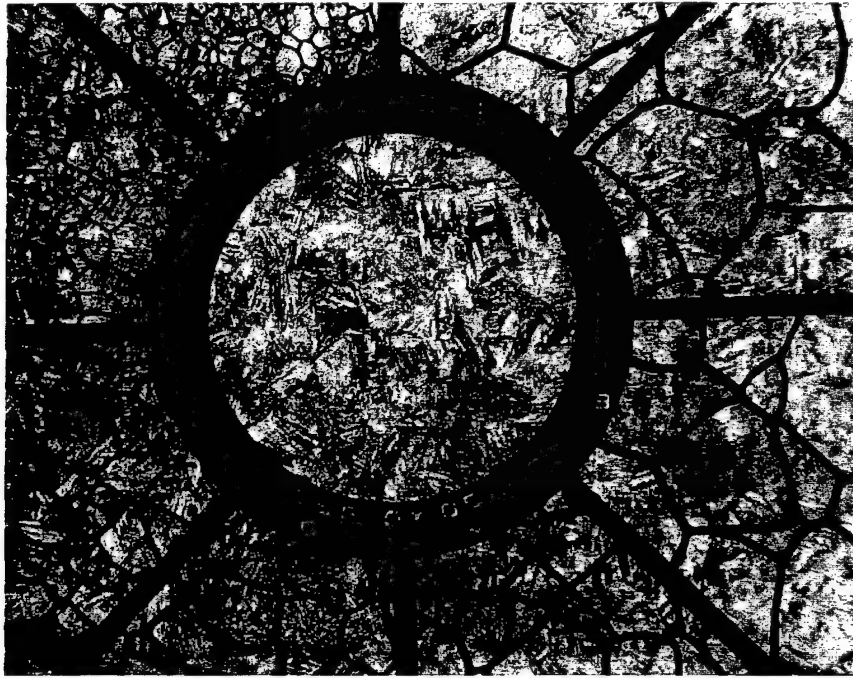
Figure D-3. Grain size of the HAAF specimen with reticle overlay.
Compare to Figure D-1 (mag. 100 \times).

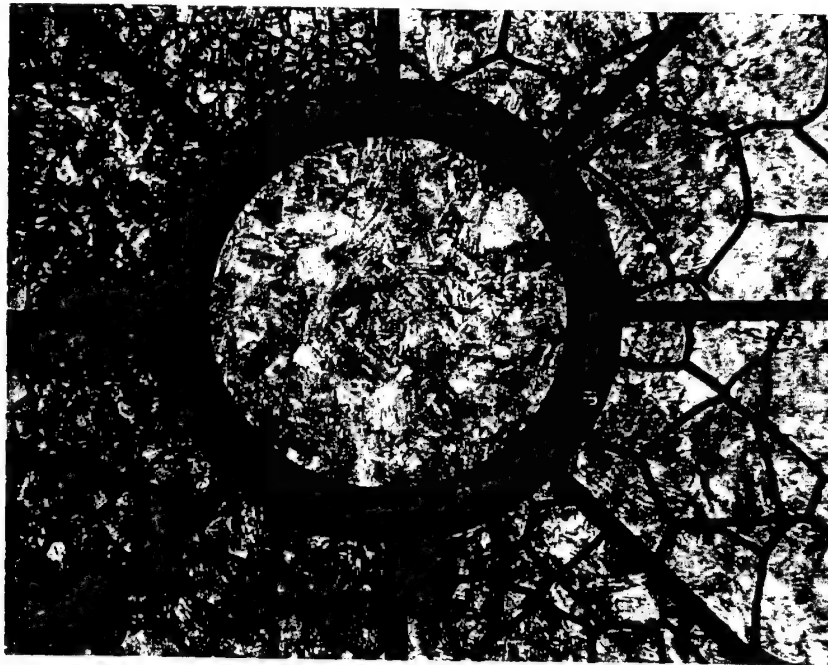
Figure D-5. Grain size of the Ft. Lewis specimen with reticle overlay. Compare to Figure D-1 (mag. 100 \times).
